# Manhole makeover

Engineering solutions  
for a successful renewal program

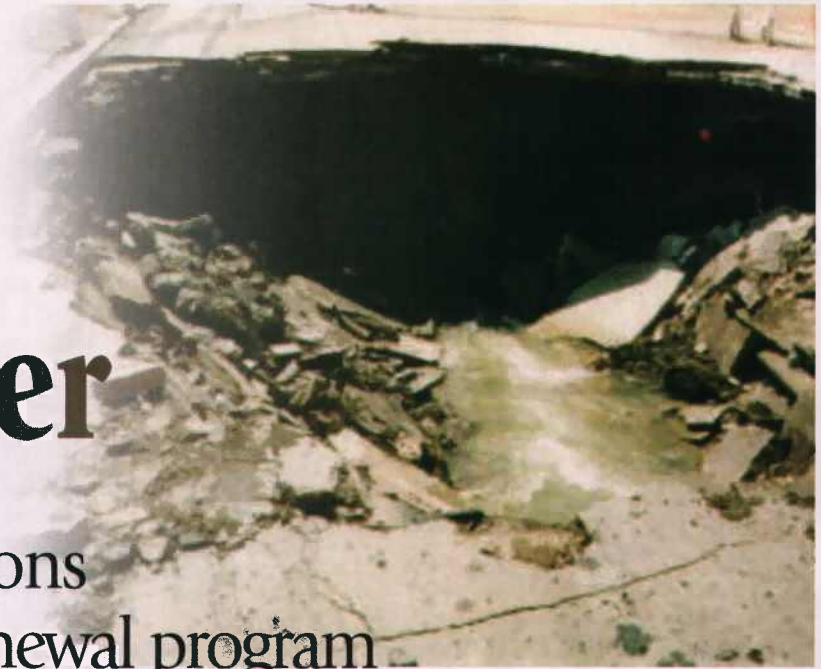
**When neglected, erosion from groundwater intrusion, corrosion from liquids and gases, and wear from dynamic traffic loads can lead to complete collapse of a manhole.**

Old manholes in particular can suffer from serious problems. They are subject to erosion from groundwater intrusion, corrosion from liquids and gases, wear from dynamic traffic loads, and general deterioration from age. Any

of these processes create structural fatigue or cause substantial inflow or infiltration. Out of sight, degradation is not easily monitored, but when neglected, complete collapse is likely.

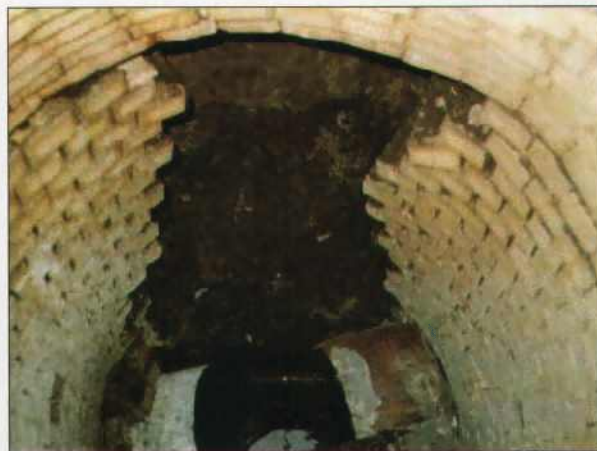
**On a brick manhole, water movement can remove mortar, leading to the loss of bricks and eventual structural failure.**

rienced ongoing infiltration. Over time, this constant intrusion takes a toll on a rigid structure. On a brick manhole, water movement will remove mortar between bricks, contributing to the loss of bricks and increasing the potential for failure of the structure.

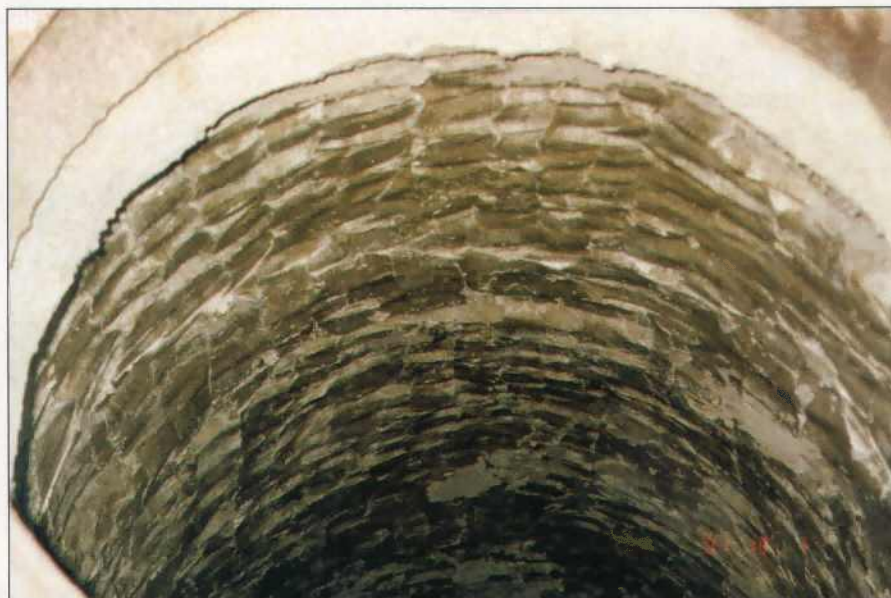
**Leaks that have not resulted in structural erosion can be sealed with water plug or chemical grouts.**

Individual leaks that have not resulted in structural erosion can be sealed with water plug or chemical grouts. Likewise, eroded benches and leaking channels can be patched and sealed. Additionally, damaged steps create a serious hazard and should be removed. In fact, most U.S. cities choose not to replace steps to reduce liability for unauthorized entry. Workers use safety harnesses and tripods for entry.

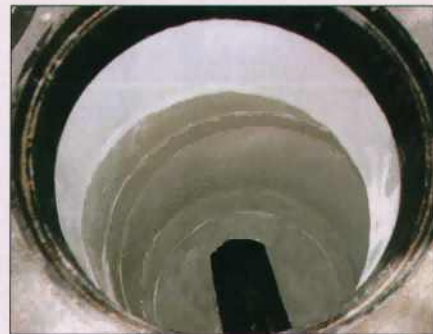
**In corrosive environments, a manhole can be replaced without digging by installing a plastic liner fitted to a form, and filling the annulus space between the form and the old wall with concrete.**

Two, less expensive options are no-dig and partial-dig solutions. No-dig methods use forms, which can be passed through existing openings and assembled entirely within the old manhole. An annulus space between the forms and the old wall is filled with standard, department of transportation-specification ready-mixed concrete and vibrated into place creating a new, joint-free wall about 3 inches thick. In corrosive environments, a plastic liner with interlocking protrusions is fitted onto the form before placement of the concrete so that when the forms are removed, a fully plastic-lined concrete manhole remains in place.
