REPORT OF STATIC LOAD TESTING

PROJECT:
HDPE ADJUSTING RINGS
STATIC LOAD TESTING

AET PROJECT NO: 05-04911

DATE: OCTOBER 11, 2010

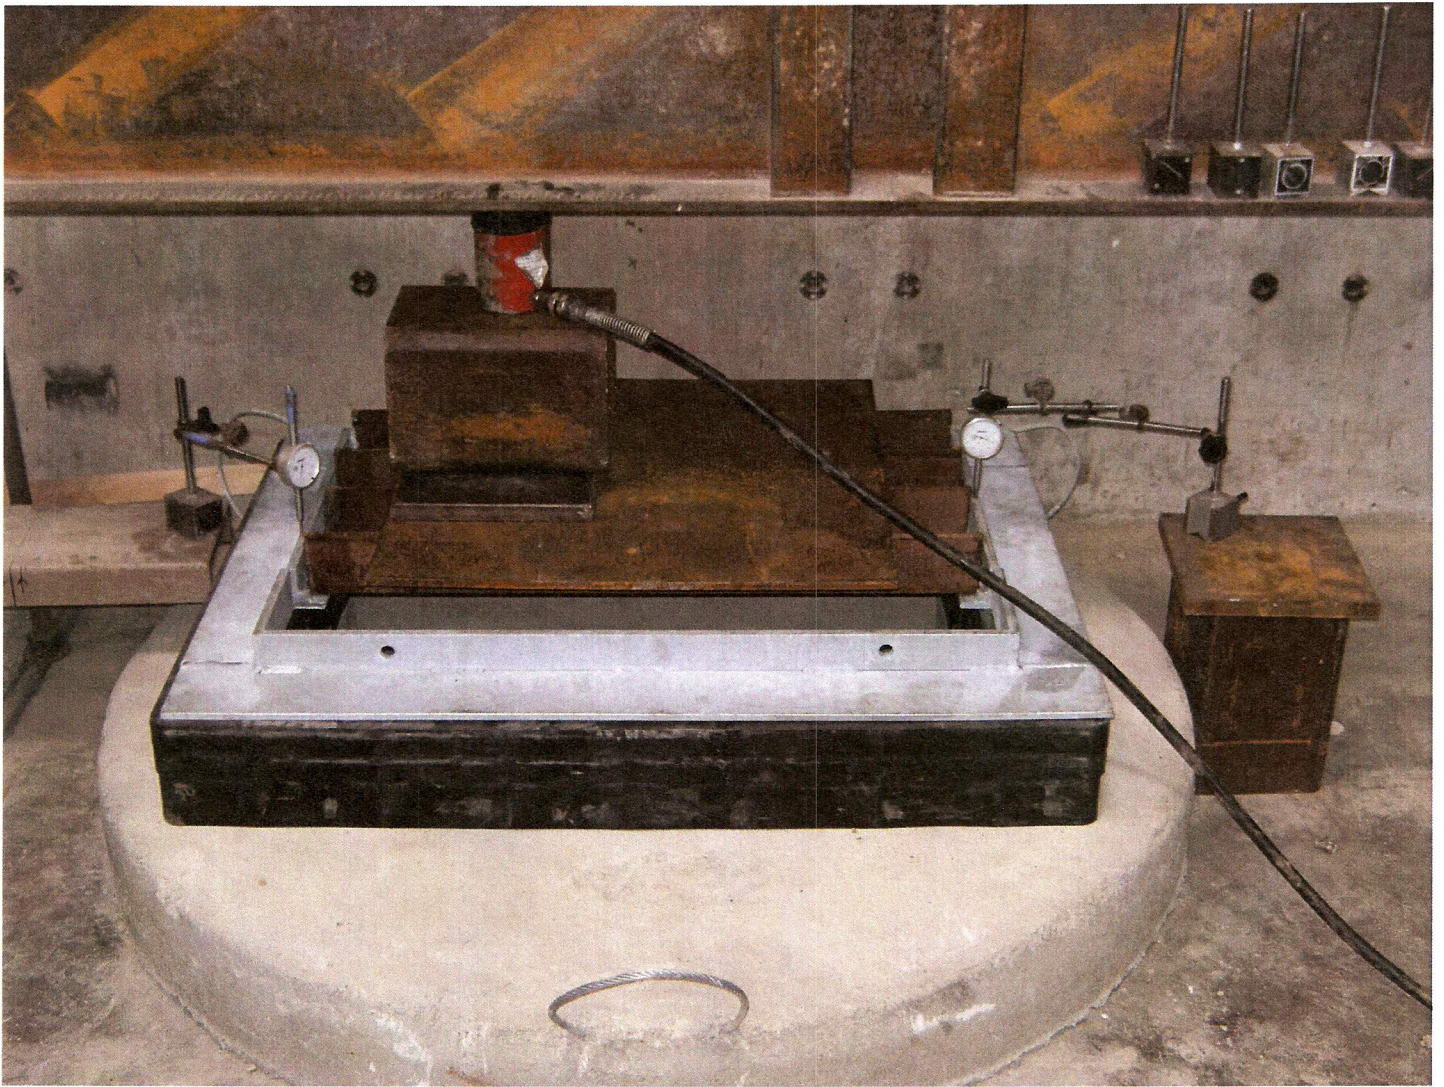
Photo 1: Test setup

Representative photographs and a sketch of the test assembly are attached to this report.

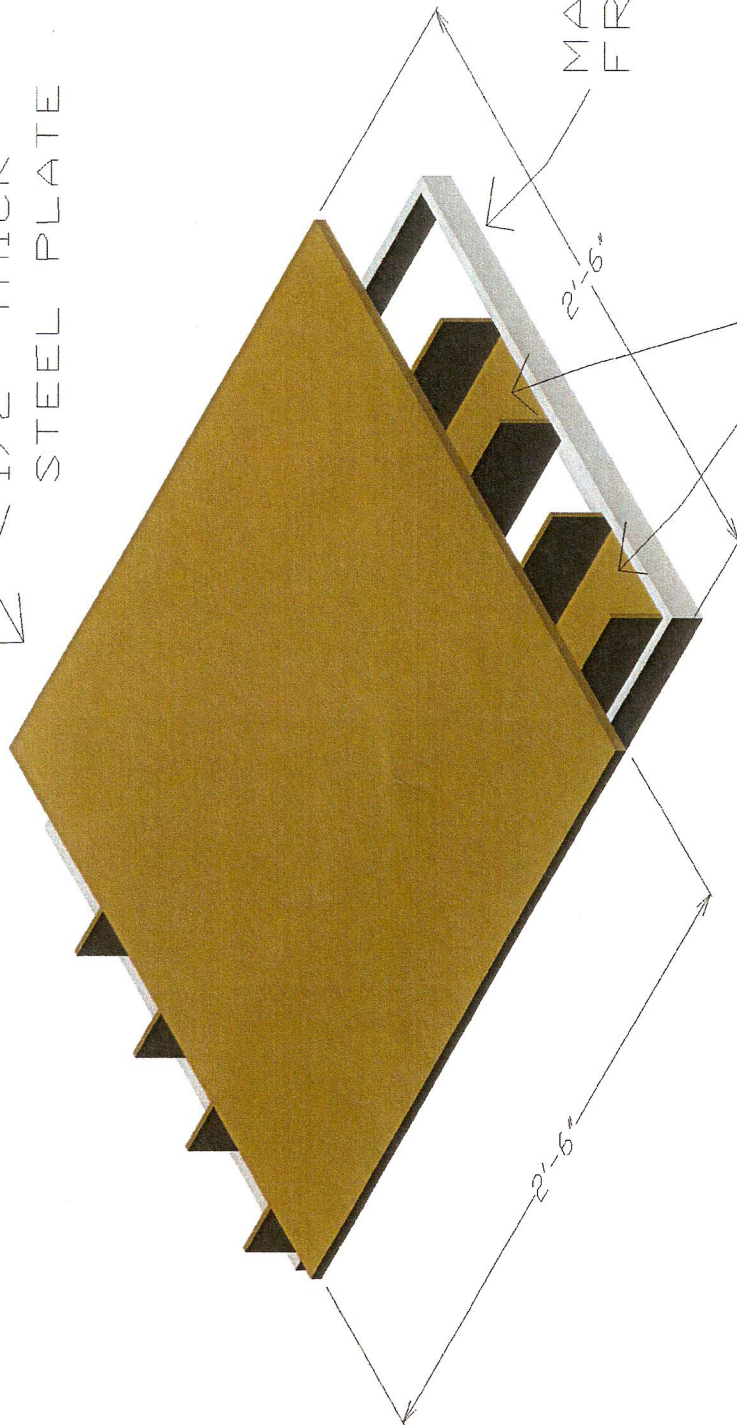
1/2" THICK
STEEL PLATE

MANHOLE
FRAME

2 - 6" STEEL
CHANNELS BEARING
ON LIP OF FRAME

LOADING PLATE

A steel manhole frame and cast iron grate were provided by LADTECH to facilitate loading of the adjusting rings. During Test #1, the grate cracked at a load of approximately 20,000 lbs. AET fabricated a new loading plate in lieu of the cast iron grate which fit inside the steel frame assembly as the grate did (see attached drawing). The testing was then performed with the new loading plate.

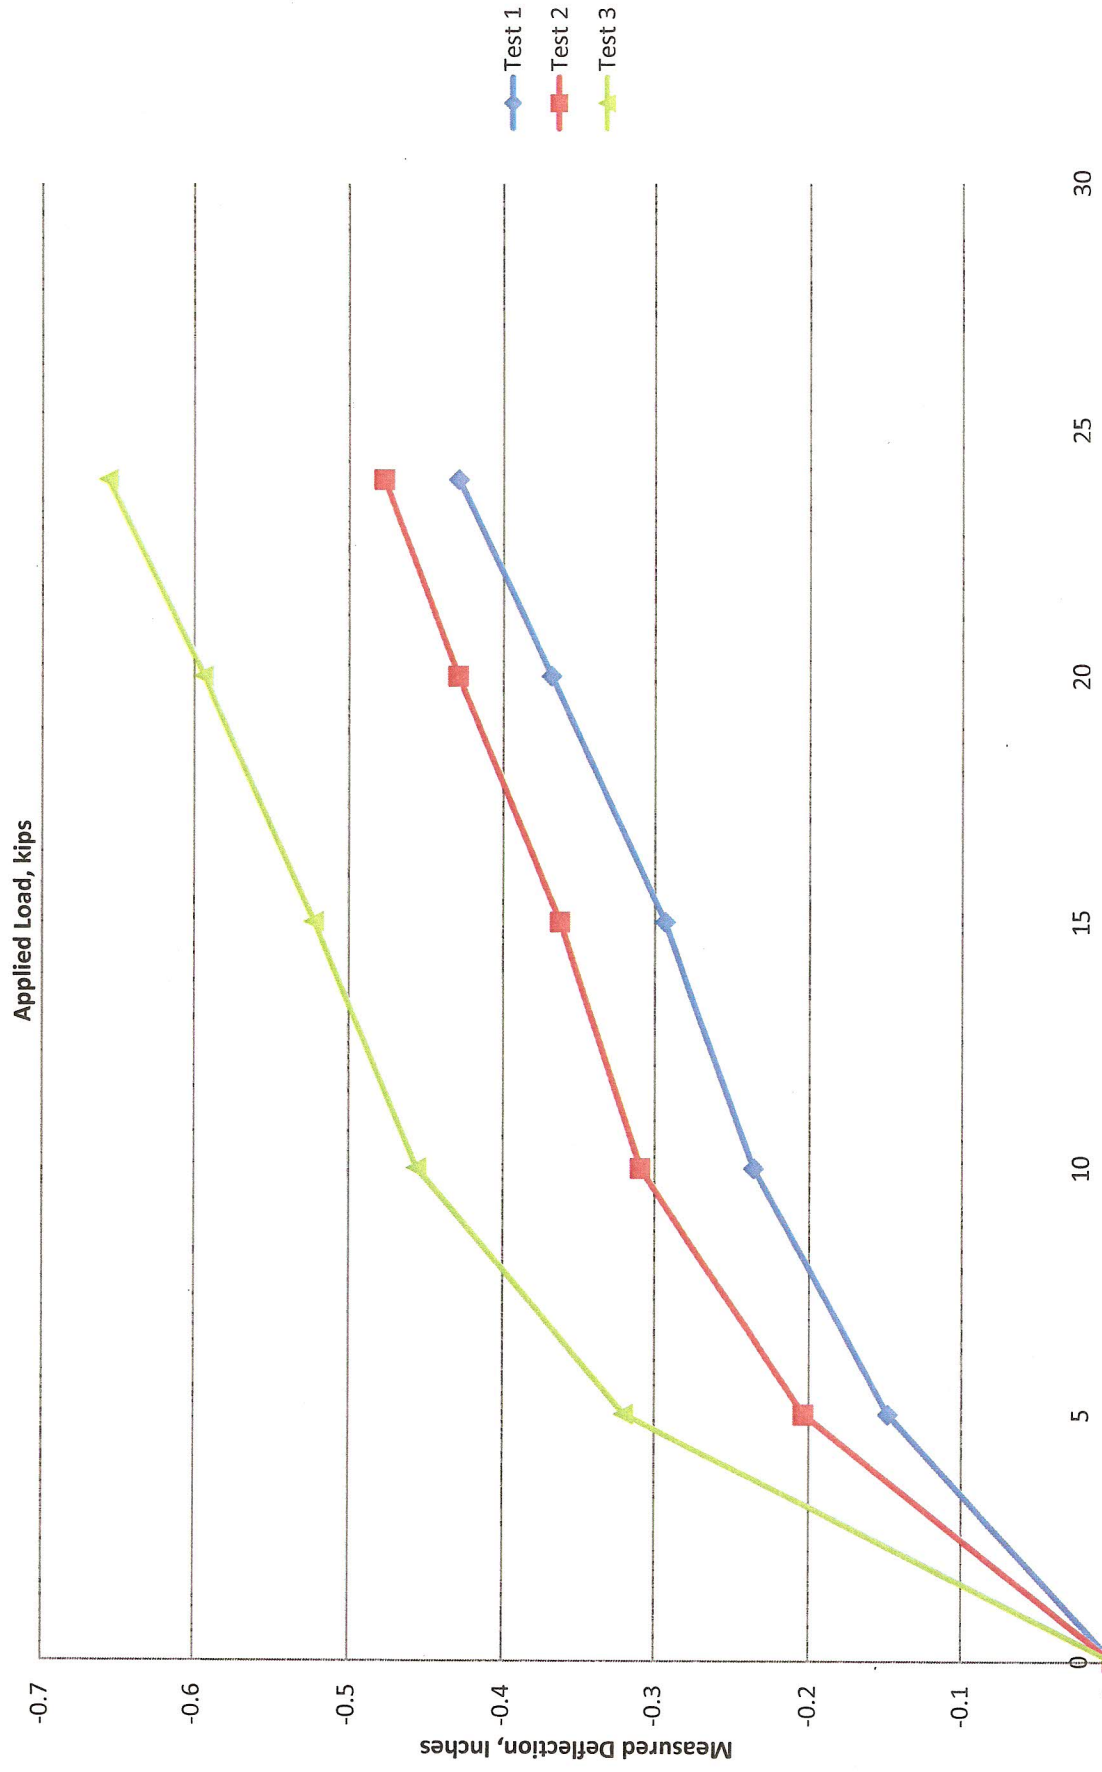
Applied Load v. Deflection Loaded Side Recordings

The load/deflection data are also shown in the attached graph. Deformation (bulging and dimpling) was minimal during loading; no cracking occurred within the ring structures during the test.

The load/deflection data are also shown in the attached graph. Slight permanent deformation of the lower rings occurred on the inner vertical surface. During the ten minute hold at 24,000 lbs., a "pop" was heard, however no pressure loss occurred in the hydraulic ram. Post-testing observations did not find any cracks in the ring structure. The sound was likely from the interface of the concrete base and cast-in-place concrete floor.

From the graph, it is apparent the load/deflection relationship for the adjusting rings is relatively linear following an initial "seating" period. No failure and minimal plastic yielding occurred under test loads as evidenced by the lack of visible distress and the rebound following removal of the load. It is likely some additional rebound would have occurred beyond the ten (10) minute rebound period.
